**Second  
International Conference  
on  
Case Histories in  
Geotechnical Engineering**

**June 1-5, 1988**

**University of Missouri-Rolla  
Rolla, Missouri**

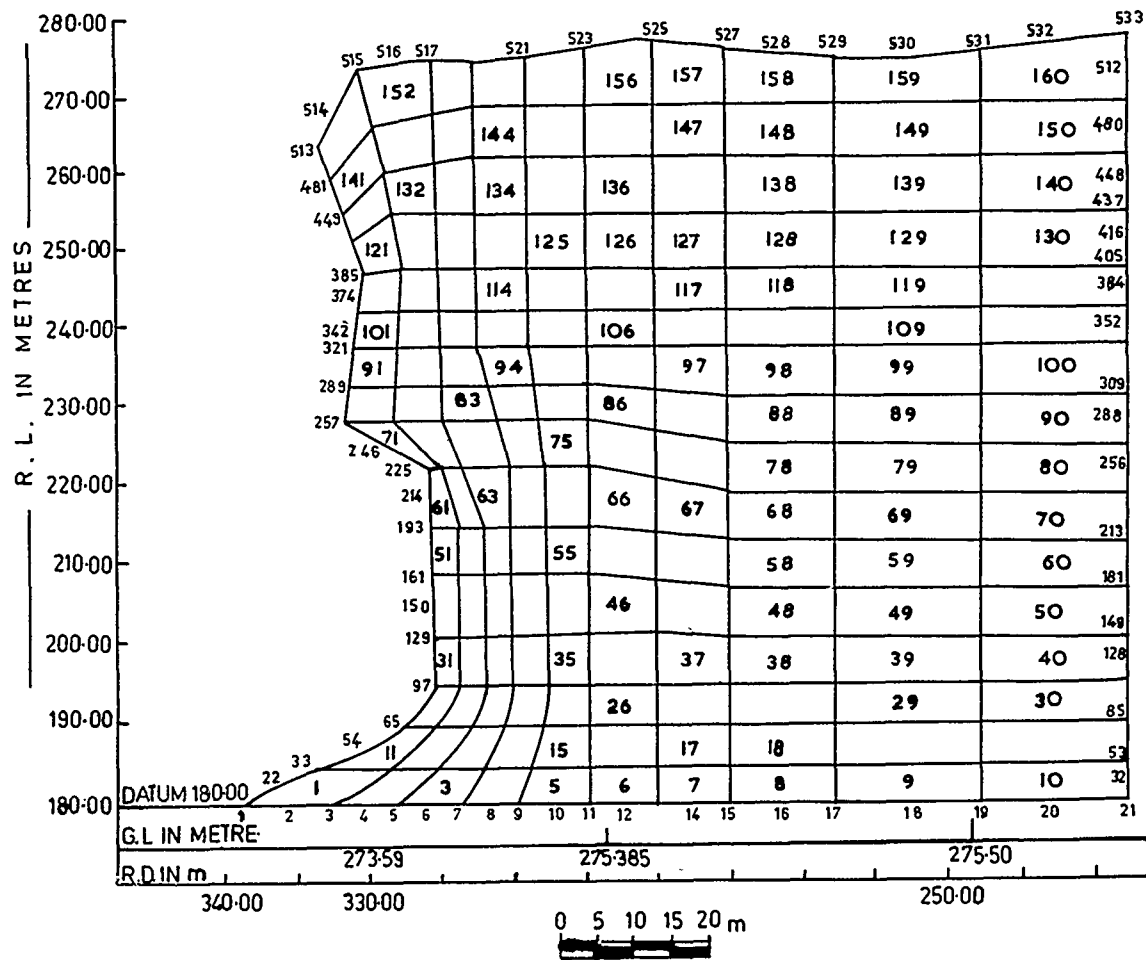
Fig.3 Finite Element Idealisation For Escarpment Near Valve House

The above check (Ref.3) for the escarpment was made from the principal stresses obtained by finite element analysis and assuming plane of failure 45, 60 and 74 degrees with the

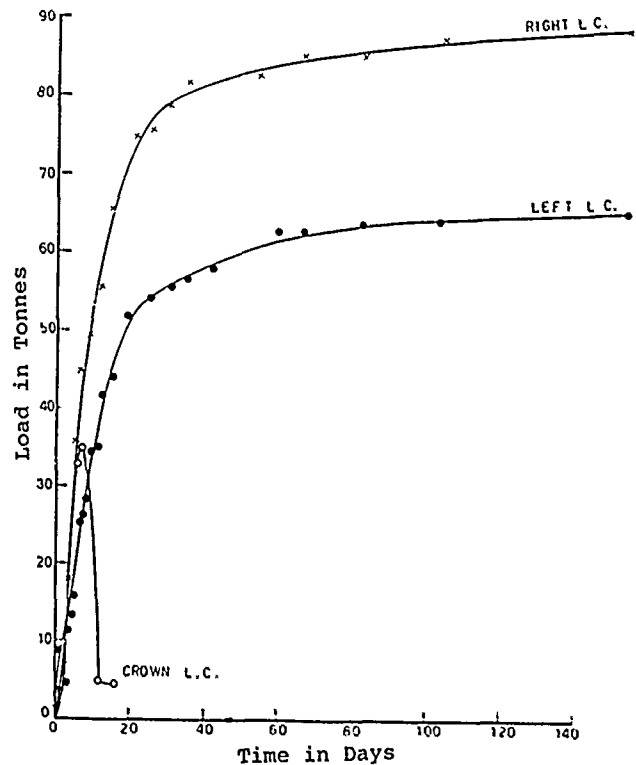
Fig. 3 Load-Time Relation for Mechanical Type Load Cells in Grade II Phyllites

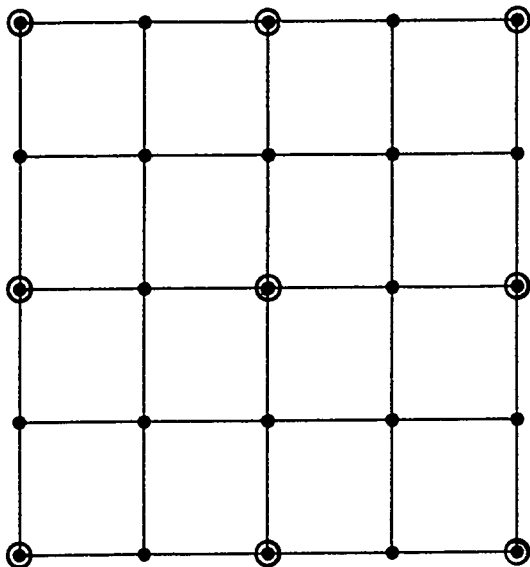
- Primary Holes on 3.2m centers
- ⊙ Injection Holes in the first pass (30% of the Pattern)

Pattern shown typical of Contractor's Grid Pattern

**Figure 1 Plan of First Pass Injection Holes**

Exploratory borings and observations inside the cavity indicated that the southern and eastern portions of the site contained the most extensive voids; therefore, the primary grouting work was initially concentrated in the southeastern corner of the site. A test area was located in this corner. A first pass grout injection pattern was developed as shown on Figure No. 1. Approximately 30% of the total number of primary holes were grouted in the first pass. Injection in the remaining 70% of the primary holes (second pass) indicated that the 30% pattern was insufficient to insure adequate ground stabi-

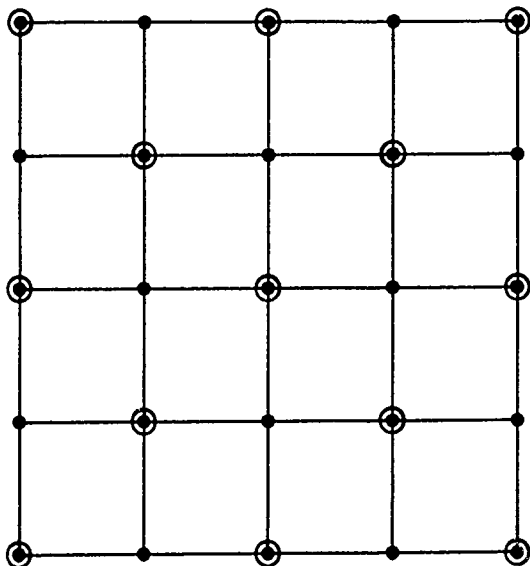
- Primary Holes on 3.2m centers
- ⊙ Injection Holes in the first pass (50% of the Pattern)

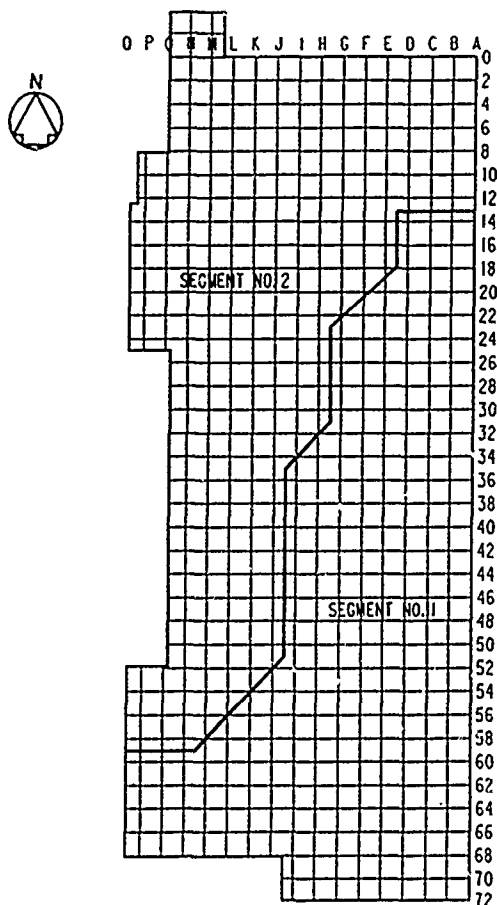
**NOTE:** Numbers and Letters Indicate Contractor's Grid Pattern on 3.2m spacing.

Test Section Was Inside Grid Lines 52 to 72 and A to I.

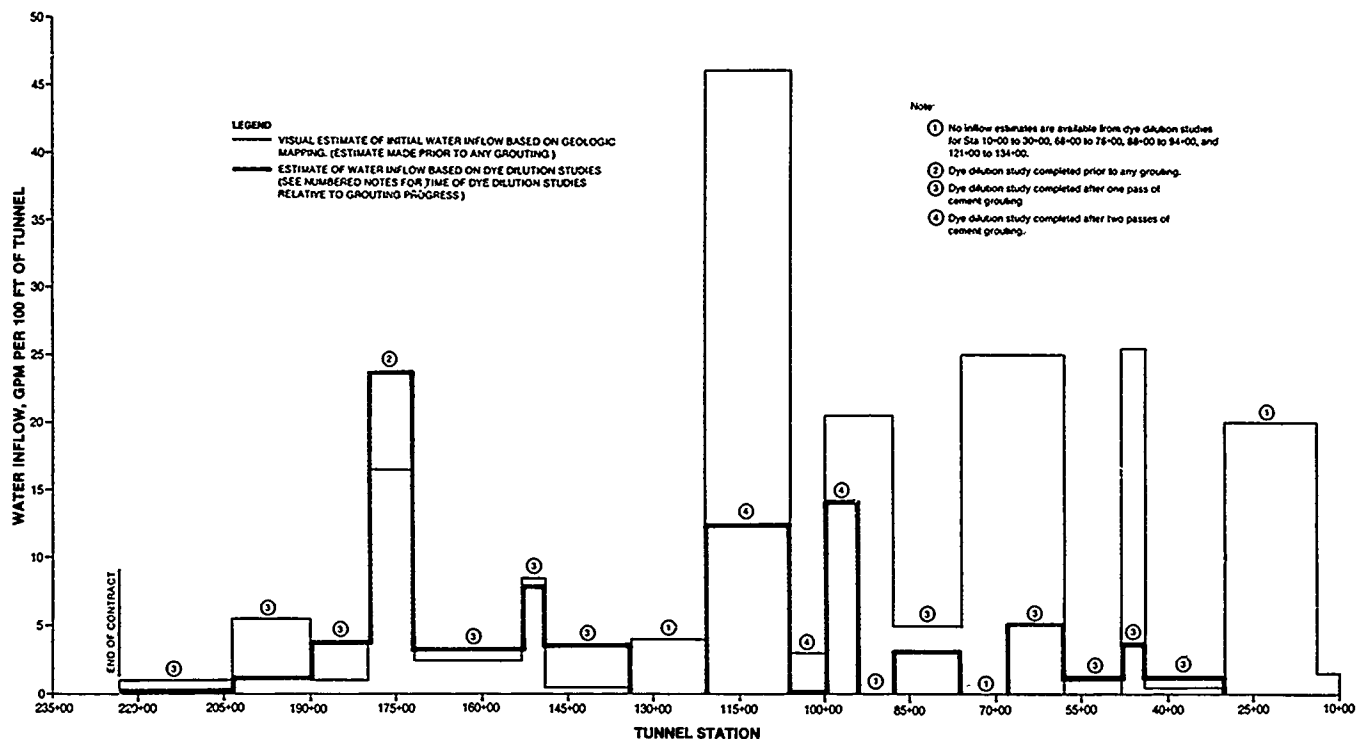
Figure 4. Water Inflows by Tunnel Section.

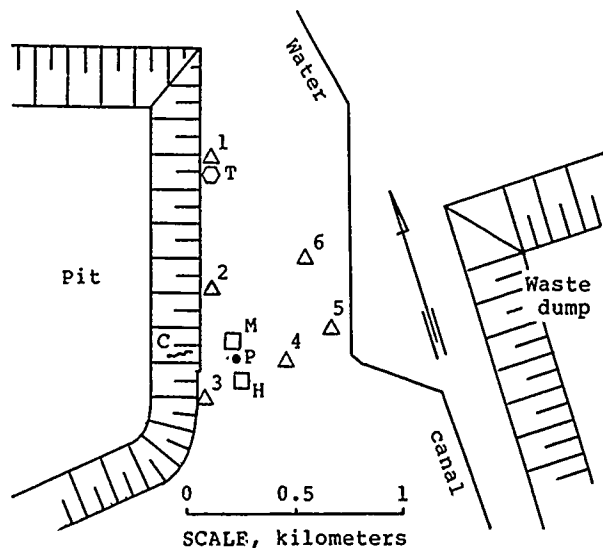
Fig. 1. Mining Situation and Elements Related to the Study on Seismic Activity. T-tower, M-monitoring station, P-piezometer, H-building, C-crack in slope, 1,2,3-geophones.

Development of the opening cut for the Belchatow open pit lignite mine in central Poland started in 1976. The depth of the opening cut reached approximately 90 m (meters) when the first tremor of magnitude 3.6 occurred in August 1979. It was sensed by the crew on the dispatcher tower (Fig. 1), which experienced a series of swinging movements. Ground movements were also strong in a small building occupied by the mine hydrogeological team (Fig. 1). The spilling of a tea on the table marked the direction of

The stress concentration meant that even for a low average disturbance of stress caused by mining and dewatering operations at the pit, a local horizontal stress in the limestone pillar could reach considerable levels (Fig. 7). This could cause either collapse of individual caves or a shear failure within the pillar itself. Location of the event in April 1980 indicated the limestone pillar as the center of the stress concentration (Fig. 4). Failure in the piezometer well (Fig. 1) adjacent to the epicentral location was considered as related to the event occurrence.

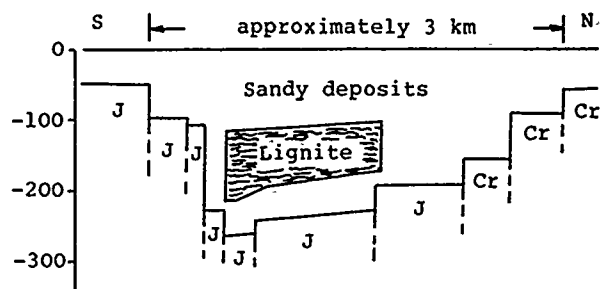
Fig. 3. Cross-section of the Belchatow Trench near the Area of Mining. J-Jurassic rock, Cr-Cretaceous rock.

lenses of boulder clays and silts (Fig. 3). Similar materials form the bedding sediments

down to the bottom of the trench. The deposit, 1.5 km wide in the area where the mining started, comes close to the southern wall of the trench. The northern edge of the deposit is separated from the northern side of the trench by a 0.5 to 1 km wide strip of Quaternary sands (Fig. 3). A map showing contours of the trench in the area of mining (reconstruction) is presented in Figure 4.

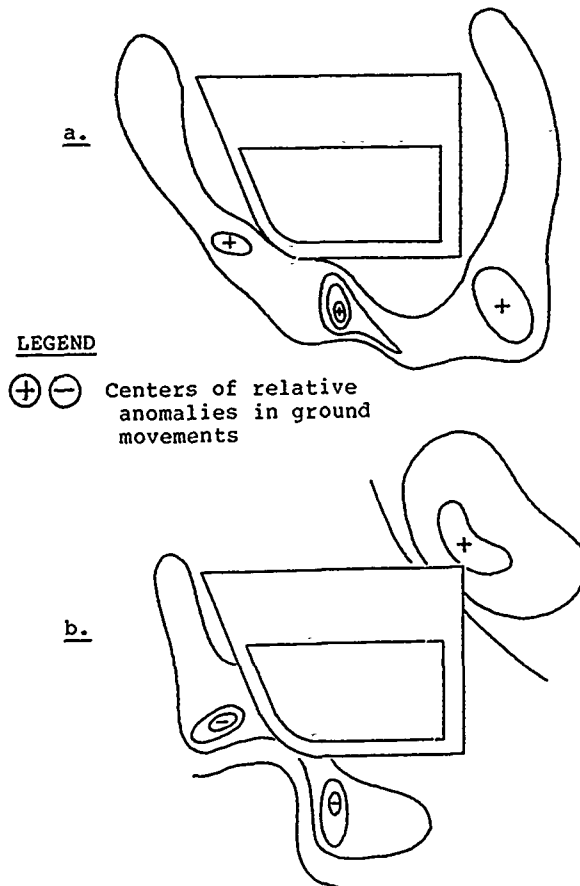
Fig. 5. Idealized Anomalies in Increments of Ground Vertical Movements: a. forced by stress relief in the trench; b. after a tremor.

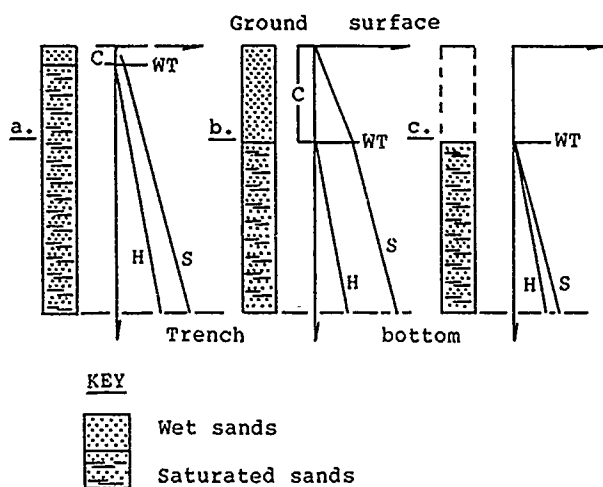
Fig. 6. Changes in Vertical Stress, Hydraulic Pressure, and Cohesion Zone in Loose Materials (a) as caused by Dewatering (b), and Overburden Removal (c). C-cohesion zone, H-hydrostatic pressure, S-effective stress, WT-water table.

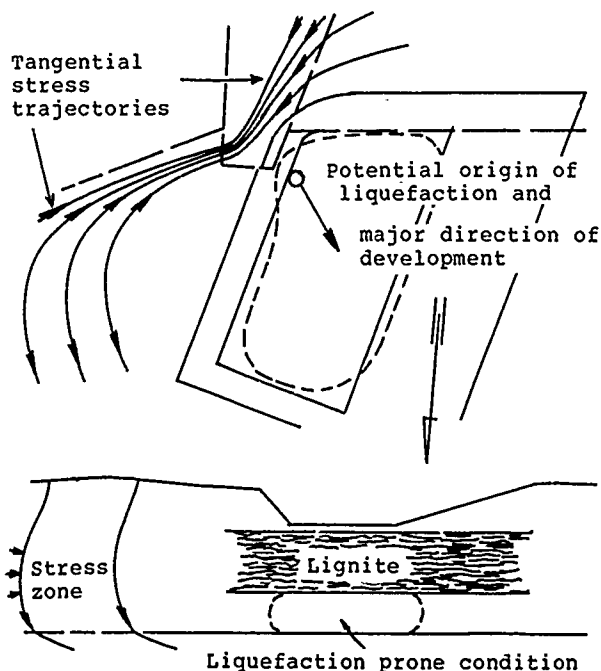
Fig. 7. Stress Zones and Liquefaction Prone Area Developed Around the Pit.

materials from the north (Fig. 7). The highest level of stress concentration (high shear stress) developed in the limestone pillar. Local centers of the stress concentration within this pillar and in the adjacent portion of the southern wall of the trench were expected to develop earlier as a result of draining water from karst caves and tunnels.

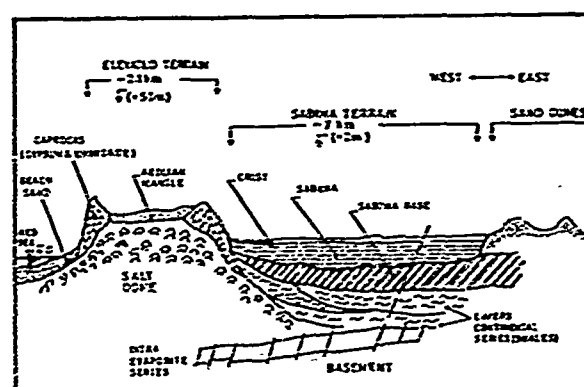
Fig. 1 Representative cross section of Jazan region

The town of Jazan is situated on an elevated terrain underlain by a salt dome measuring 4 sq. kms in area and reaching about 50m. above the sea level. The salt dome is surrounded by a coastal plain in the southwest corner of Saudi Arabia. The coastal plain which is planned as the redevelopment area in the region, stretches north and south for approximately 190 kms. A schematic geological cross section of the region is shown in Fig. 1.

water, appear as high ridges, as shown in Fig. 1. The gypsum and anhydrite hills enclose the low lying area which is covered by sand dune deposits. This topographic feature can be attributed to a long term collapse mechanism associated with the dissolution of salt rock by groundwater (Al-Mutairi, 1985).

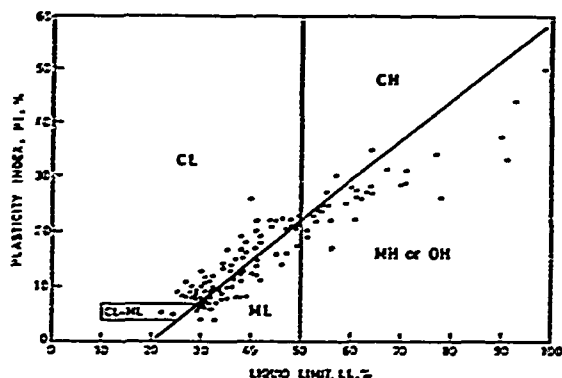
Fig. 2 Consistency limits of sabkha sediments

The area surrounding the elevated terrain (salt dome) is essentially flat, and is covered by thick sediments of soft/loose organic saline soils which are referred to as sabkha deposits in published literature (Akili et al, 1981). In the sabkha terrain three zones comprise the soil profile: i. sabkha crust; ii. compressible sabkha complex and; iii. sabkha base. The sabkha crust has an average thickness of 1.5m and is a mixture of fine sand and silt size particles encrusted by precipitations of soluble salts resulting from evaporation of saline groundwater. The middle zone is composed of soils varying from non-plastic fine sands to highly plastic organic clays. Variety of materials, mutually interlayered at random, occur in sabkha complexes without exhibiting any real stratification. The distinct feature of sabkha deposits is their poor mechanical properties and heterogeneous nature. Their highly variable compressibilities coupled with significantly low bearing resistances often give rise to serious geotechnical problems (Jullie et al, 1983; Khan et al, 1981; Akili, 1981). The plasticity characteristics of the sabkhas from Jazan region, shown in Fig. 2., reflect the variable nature of the sediments.

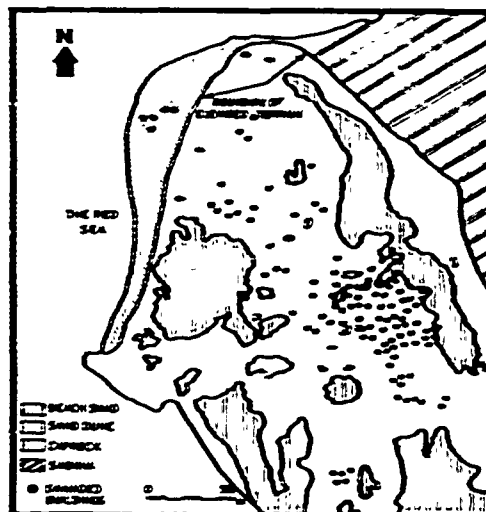
Fig. 3 The distribution of damaged structures in the old town

The most populated part of the city is situated on the elevated terrain which is underlain by the salt dome. In this section of the city numerous buildings have been damaged beyond repair. The distribution of existing damaged structures are shown in Fig.3. Typical extent of damages observed in the distressed buildings are illustrated in Fig. 4. In some heavily damaged buildings the ground movements caused

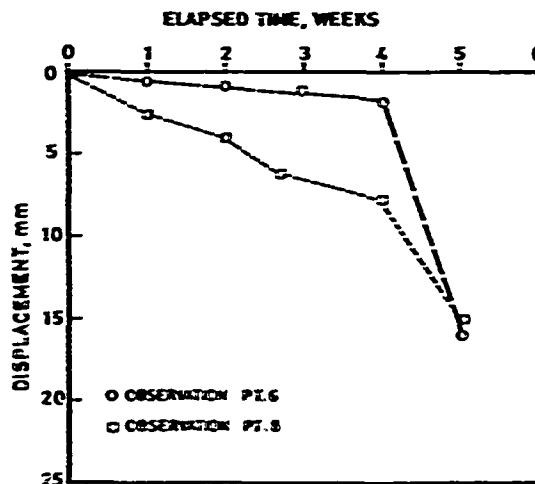
Fig. 6 Ground movements observed in the inundated site

In order to ascertain that the dissolution of salt rock is the primary cause of the damages, some field measurements were taken in the site of an deserted factory buildings. The movements at the ground level were monitored while the site was artificially inundated. The displacements measured upon wetting of the site are shown in Fig. 6. It is interesting to note that the elapsed time of 4 weeks which corresponds to noticeable acceleration of settlements in Fig. 6, coincides with a heavy rainfall which lasted few hours in the city. Almost immediate response of the ground to the artificial wetting and the

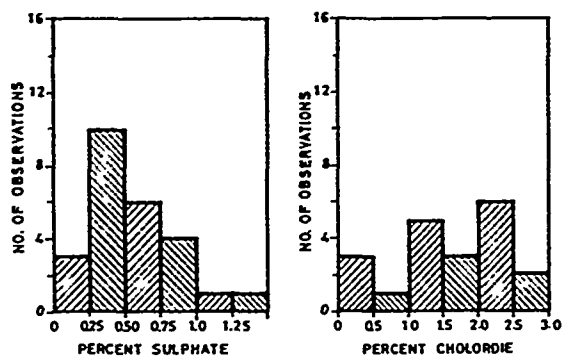
Fig. 7 Evaporite contents in windblown sand

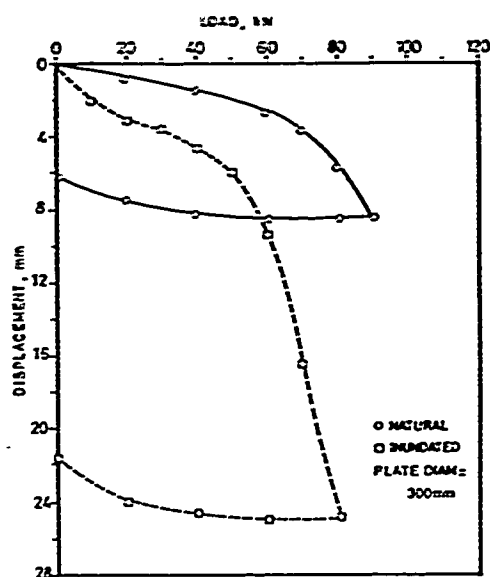
Fig. 8 Typical plate load test data reflecting the collapsing nature of windblown sands.

The results of double oedometer tests on cemented sand specimens indicated that collapse severity of the sand fall into "moderate trouble" to "trouble" categories according to the collapse classification criteria proposed by Knight (1963). The studies on collapse behaviour of the windblown sands included in-situ plate load tests which are performed in natural and inundated state. The load-displacement curves obtained from plate load tests, in Fig. 8, confirm the relatively high collapse potential of the soils predicted by the double oedometer tests. Thus it is believed that some of the damages in the region may be attributed to the collapse of the windblown sands due to wetting of the ground following the occupation of the land. However, collapse phenomenon can not solely account for the unprecedented magnitude of the ground movements experienced in the region. The subsidence phenomenon is to be considered as the major contributor to ground displacements.

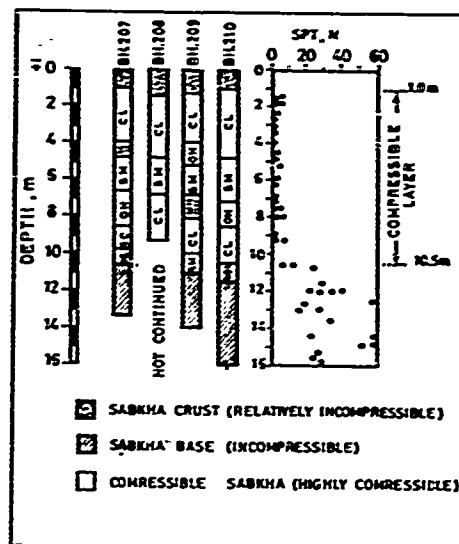
Fig. 9 Variations in sabkha subsurface profiles

From geotechnical engineering point of view, sabkha sediments are highly variable in lateral and vertical extent. Variations have been noted in terms of layering, soil composition, cementation, organic content and mineral constituent. Lateral variation appears to depend on proximity with respect to shore line, whereas vertical variation arises from development sequence of sabkha sediments, prevailing depositional environment, and subsequent diagenesis (Akili et al. 1981). The borehole profiles given in Fig. 9 from an area measuring 40x40 sqm in the sabkha terrain reflect the heterogeneity of the sabkha profiles. The heterogeneous character of the deposits lead to difficulties and uncertainties in the analysis of sabkha behaviour.

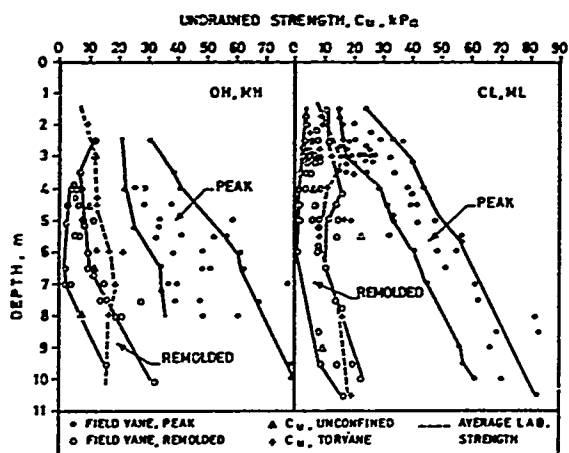
Fig. 11 Shear strength characteristics of sabkha sediments

The range of undrained shear strengths measured on sabkha deposits are shown in Fig. 11. The undrained shear strengths obtained from field vane tests, which are referred to as peak and remolded strengths in Fig. 11, and various laboratory tests

vary over a range from 5 to 40 KPa at shallow depths. This magnitude of soil strength is not adequate to support most of the common engineering structures through conventional shallow foundation systems. Thus either special foundation systems and/or ground improvement techniques are to be considered to avoid possible failures of foundations. Presently the phase of the study which concerns with selection of the most appropriate foundation methodology for the particular ground conditions is under consideration.

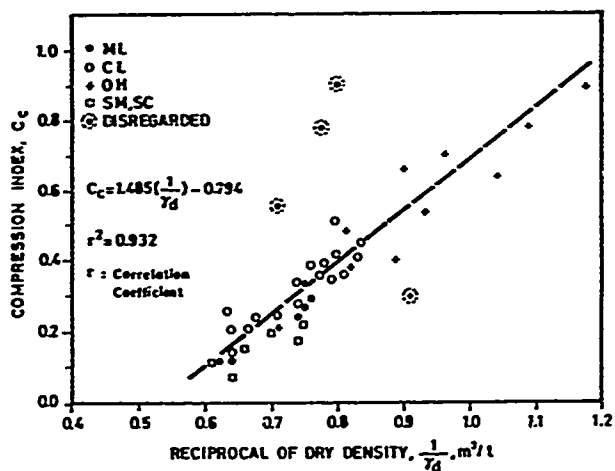
Fig. 12 Compressibility characteristics of sabkha sediments

Laboratory and field investigations were carried out to study the compressibility characteristics of the sabkhas in the region. Laboratory studies included numerous oedometer tests on undisturbed samples. An instrumented test embankment was constructed to investigate the in-situ compressibility behaviour of sabkha profiles. The range of compression indices of different soil types obtained from oedometer tests are shown in Fig. 12. Compression

indices,  $C_c$  vary over a wide range (i.e. from 0.1 to 1.0) depending on predominant soil type in the stratum, and correlates well with the reciprocal of dry density. Relatively high magnitudes of  $C_c$  clearly reflects the compressible nature of the sabkhas. This observation is confirmed by the settlements monitored in the instrumented test section where a total settlement of about 200 mm were measured under an embankment loading of 48.6 KPa. This magnitude of settlements under moderate loading conditions is beyond the permissible range for most engineering structures. Moreover, potential variation of compressibility characteristics of sabkha sediments may lead to excessive differential settlements and subsequent failures.

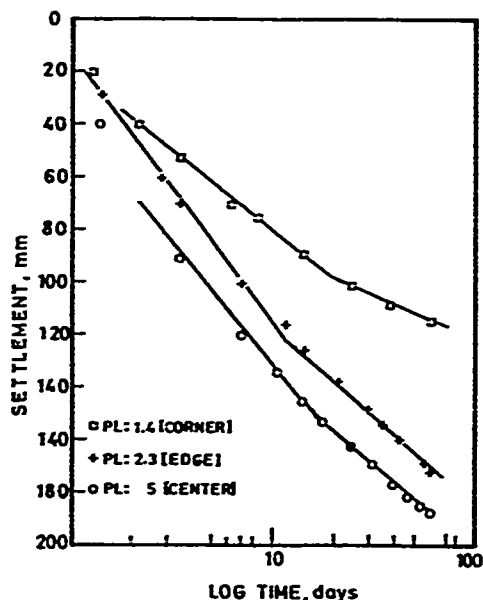
Fig. 13 In-situ settlements versus log-time plots showing the secondary consolidation effects

The in-situ measurements indicated that field settlements extend out on to a secondary consolidation phase within a relatively short period of time. The settlement log-time plots given in Fig. 13 are represented by two straight lines which are typical for organic soils and taken to indicate primary and secondary compression ranges (Long et al. 1984). The secondary consolidation problem which is usually overlooked in routine geotechnical investigations appears to be a serious problem in sabkha sediments since secondary compression may reach to significant magnitudes as evidenced by the field data.

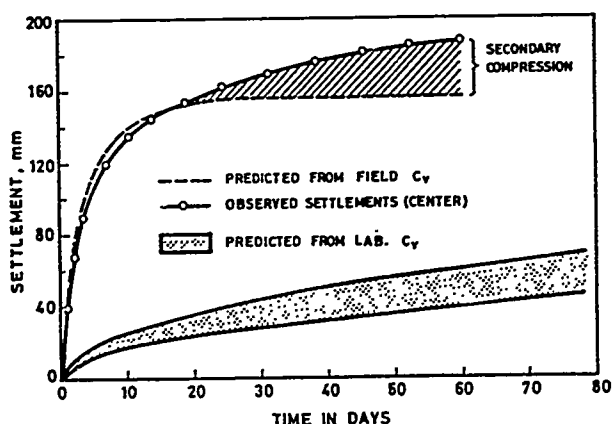
Fig. 14 Comparison of measured and predicted time settlement behaviour

the observed and predicted settlements given in Fig. 14 indicate that despite the primary consolidation settlements can be predicted from laboratory determined parameters within acceptable limits, time-settlement predictions are far from being realistic. This observation stresses the fact that the routine sampling and laboratory testing methods are not adequate for heterogeneous and complex subsoil profiles to represent the in-situ conditions. Large scale loading tests with the measurement of in-situ para-

meters are essential to achieve reliable predictions of time-settlement behaviour particularly if preloading schemes are employed to improve the ground conditions.

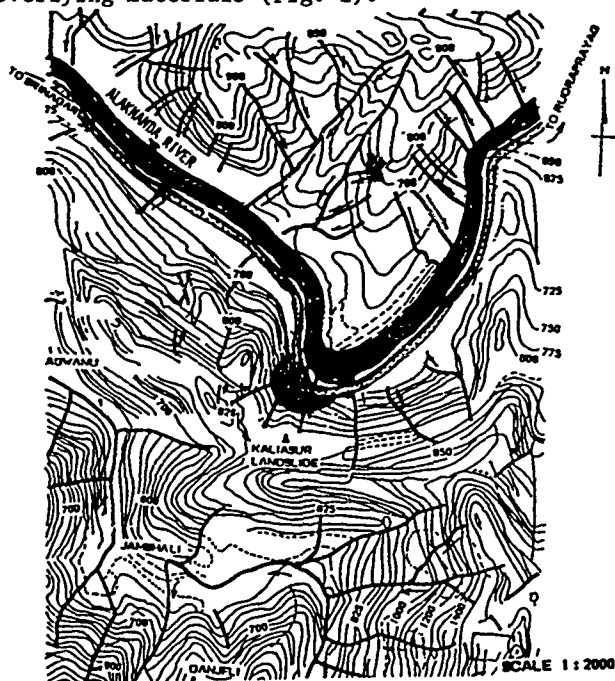
FIG. 2 - CONTOUR MAP SHOWING THE LOCATION OF KALIASAUR LANDSLIDE

The slope forming material consists of weathered, loose, crushed and pulverised rockmass mainly of quartzites and shales. The slide is constantly on the move particularly during the monsoon season (June-September) when the debris flow and rock fall are quite severe. These mass-movements are caused mainly by heavy precipitation and consequent development of hydrostatic pressure build up in the colluvium in highly fractured and jointed rock mass. In addition, extensive toe erosion by meandering Alaknanda river also cause progressive failure of the overlying materials (Fig. 2).

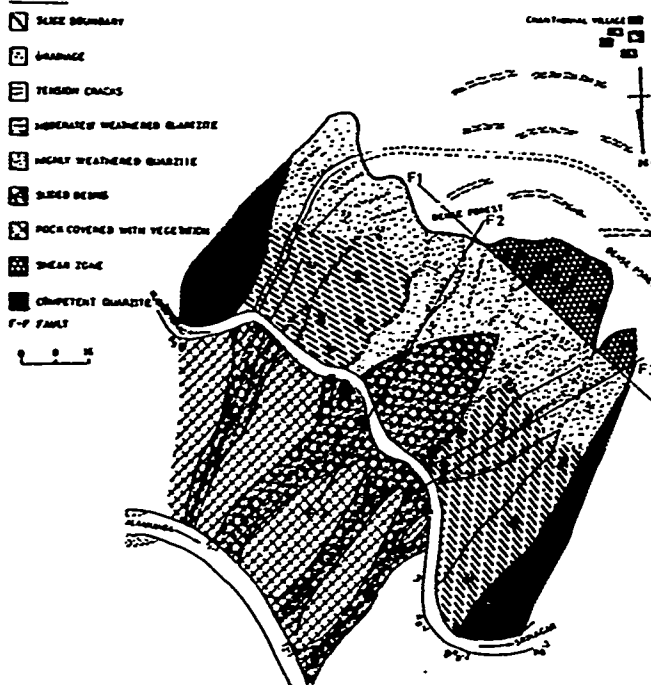
FIG. 3 - GEOLOGICAL MAP OF KALIASAUR LANDSLIDE ON HARDWAR-BADRINATH ROAD

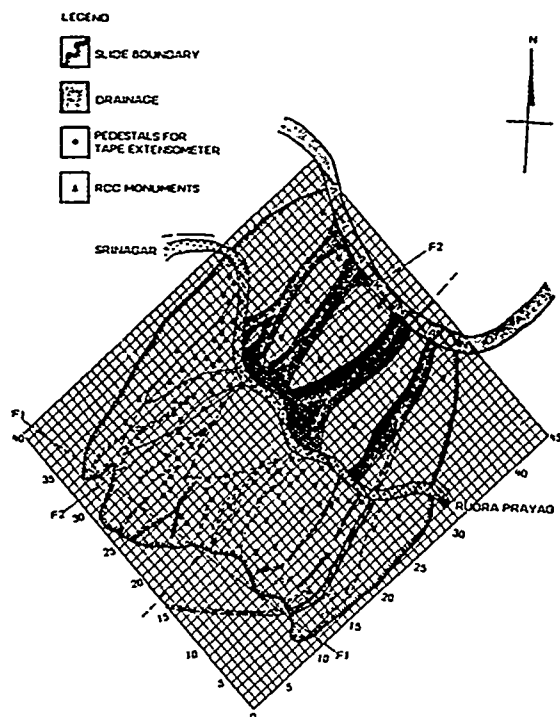
FIG. 4 - SCHEME FOR MONITORING OF SURFACE MOVEMENTS OF SLOPES AT KALIASAUR LANDSLIDE

For measurements of slope movement a scheme was drawn for locating markers for tape extensometer and geodetic triangulation observations. Grid map of the slide area was used for locating the positions of monuments and pedestals (Fig. 4). To facilitate measurements of relative surface displacements between points, 65 pedestals (markers) were installed. Measurements were made through tape extensometer and clinometer. Additionally 50 RCC pillar/monuments (markers) anchored up to 2 - 3 m depth were monitored through triangulation and high precision methods.

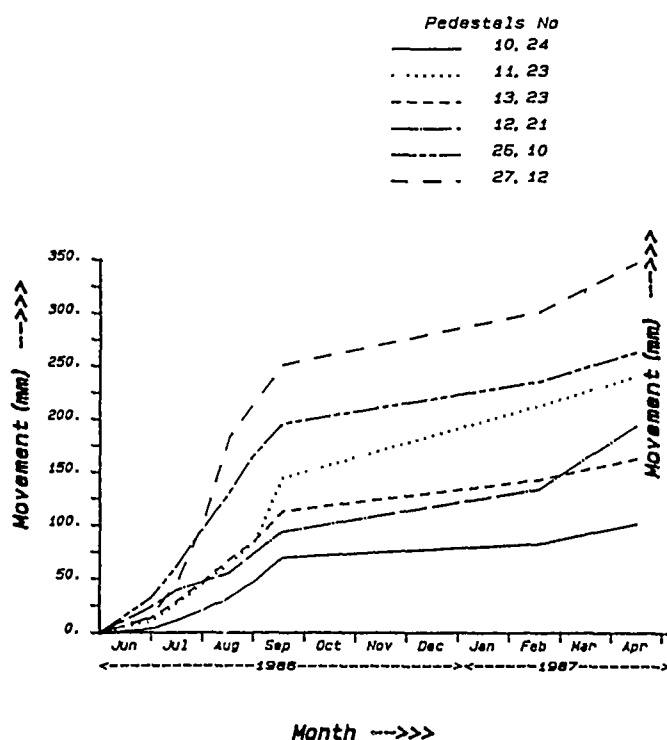
FIG. 5 - LATERAL MOVEMENT OF PEDESTALS BY TAPE EXTENSOMETER

Monitoring of surface movements were started before the onset of the monsoon in 1986. During rainy season fortnightly observations were taken. About 1000 observations have been taken so far. Some of the typical time displacement observations are shown in Fig. 5. The analysis of the data clearly indicated two directional movements - north eastern and north western - in the eastern and western sides of the slide zone (Fig. 6). The extent of the lateral movement of pedestals towards the eastern side varied from 0 - 117.8 cm whereas the pedestals on western side showed movement 0 - 76.1 cms indicating thereby that the eastern part of the slide area is more unstable.

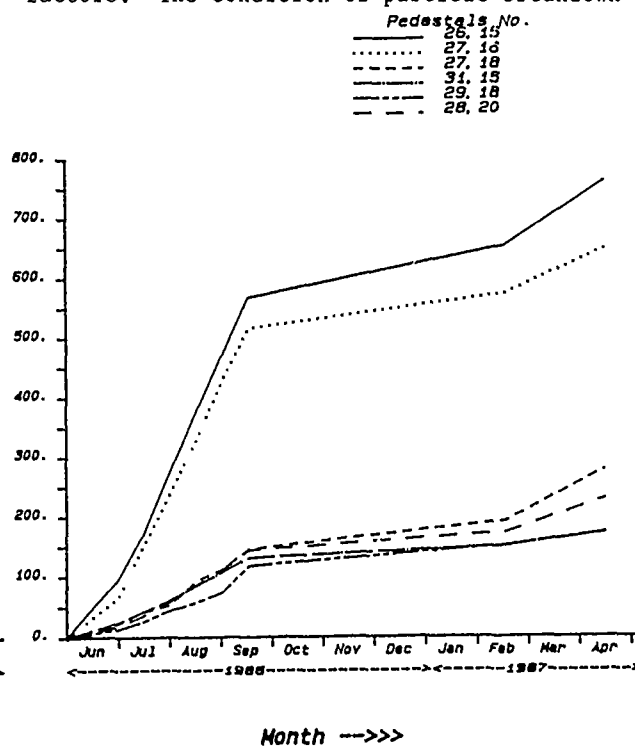
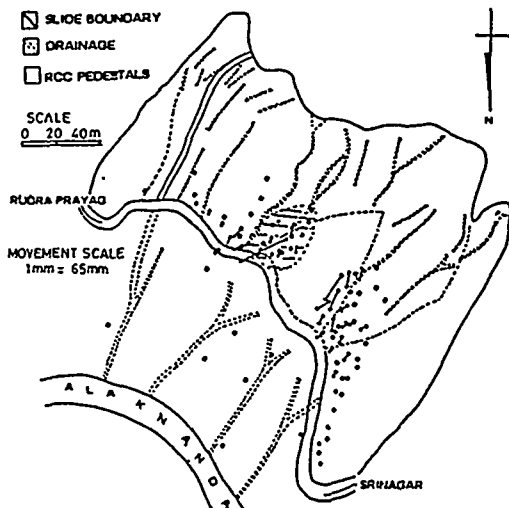
FIG. 6 - SURFACE MOVEMENT PATTERN OF KALIASAUR LAND SLIDE

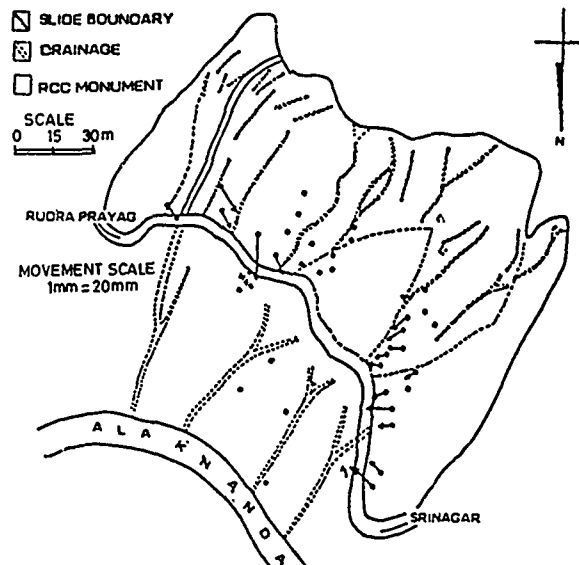
FIG. 7 - CRUSTAL MOVEMENT PATTERN OF KALIASAUR LAND SLIDE

The crustal movement studies pertaining to movement of the underlying slope material were carried out with the help of Electronic Distance Meter (EDM). The observations were taken before monsoon, during rainy season and thereafter till April 1987. The analysis of the data have shown significant lateral movement towards north east direction ranging from 0-22.5cm. The lateral movement towards north-west direction varied

from 0-17.6 cm.(Fig. 7). The results further indicated movement in vertical direction ranging from 0-6.9 cm.

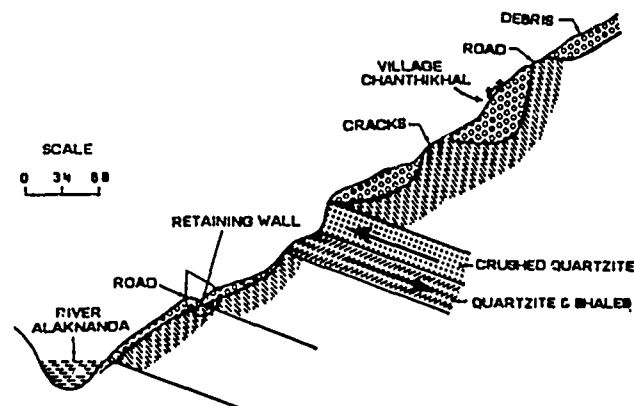
FIG. 8 - CROSS SECTION OF KALIASAUR LANDSLIDE

Kaliasaur landslide is essentially a multi-tier, retrogressive landslide in a complex rock formation with clear evidences of fault planes revealing intense tectonic activity in the geological past. Evidences of sliding at the interface of quartzites and maroon shales must presumably have been the starting point. Road construction activity in general and repeated back cutting required for restoring the road width, year after year, poor drainage, recurring debris slides in the colluvium cover on the slope robbing it of the vegetative cover and river action at the slope toe have all been responsible to develop the landslide to it's formidable size obtaining today. A typical slide cross-section is shown in Fig. 8.

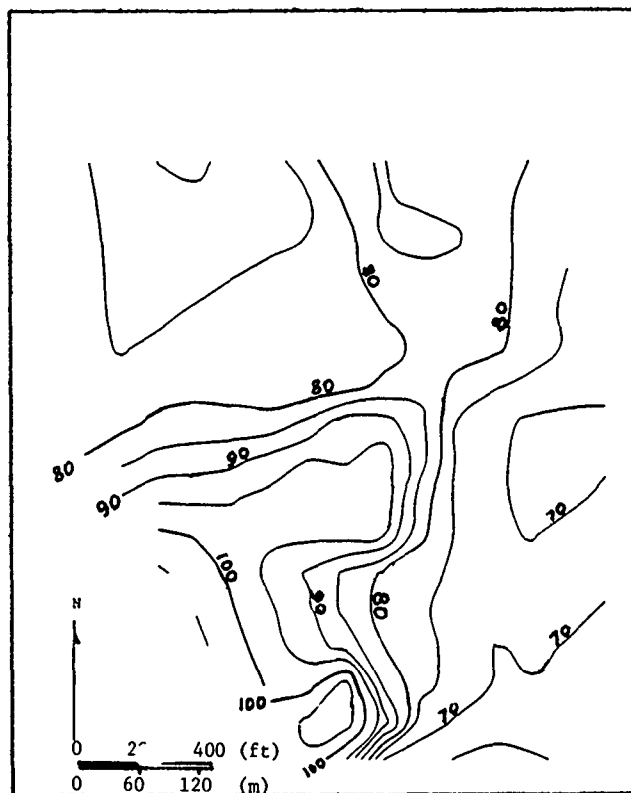
Figure 3. Unconsolidated Overburden Contours

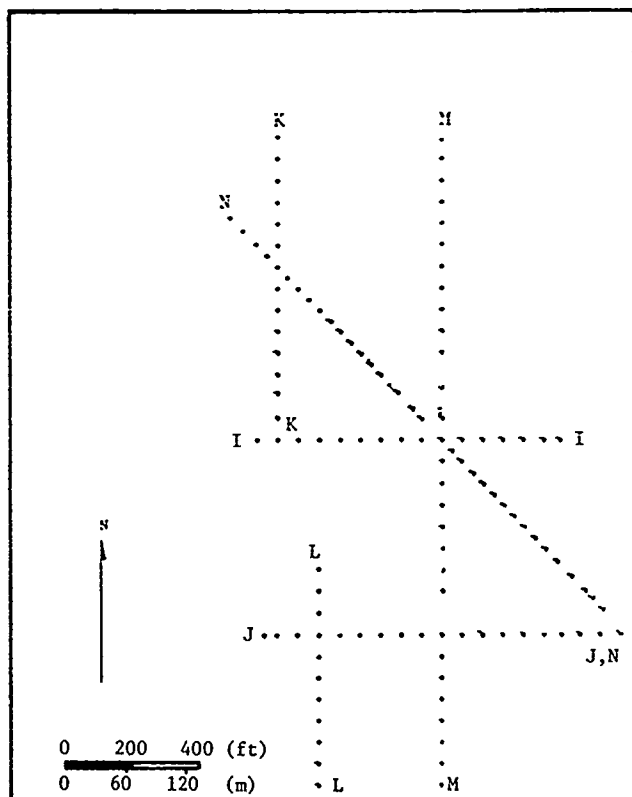
Figure 4. Survey Monuments Along the Subsidence Monitoring Grid Lines

Surface subsidence movements were monitored along six (6) lines consisting of 152 monuments (Figure 4) located at about 18 m (60 ft.) intervals. Subsidence monuments were designed to minimize freeze-thaw associated movements. The monuments were surveyed for vertical and horizontal movements with standards for Second order class II accuracy.

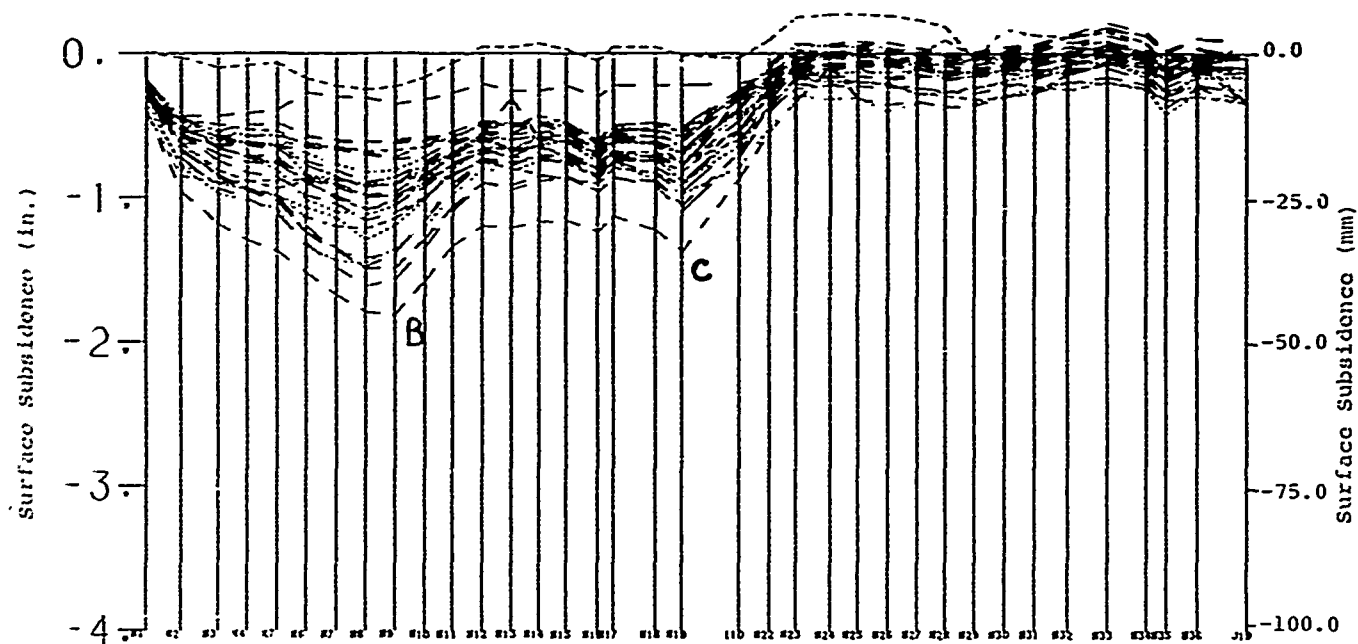
Figure 6. Surface Subsidence Cross Section  
Along N Grid

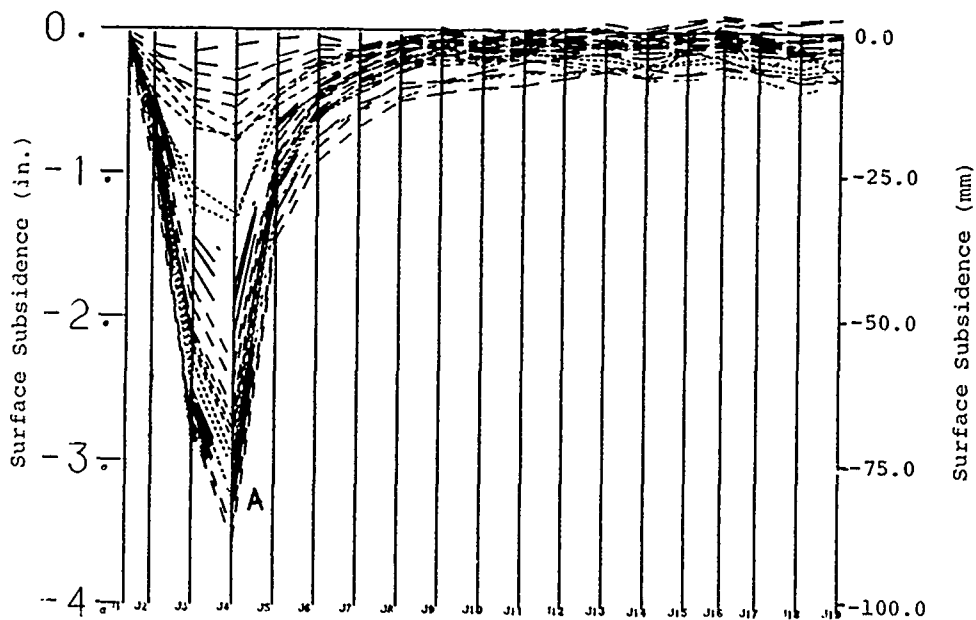
Figure 5. Surface Subsidence Cross Section  
Along J Grid

1. Vertical surface subsidence movement data (Figure 5) show gradual downward movement with time over the entire area. Surface movements over mine openings and coal pillars are approximately the same except near the barrier pillars where movements are somewhat smaller. Subsurface vertical movement data from Sondex instrumentation in boreholes over the coal pillars (Figure 8) also show downward movement in lower portions of the pillar near the claystone floor. Over the 16-month study period, approximately 12 mm (0.5 in.) of compressional settlement is noted in the area.

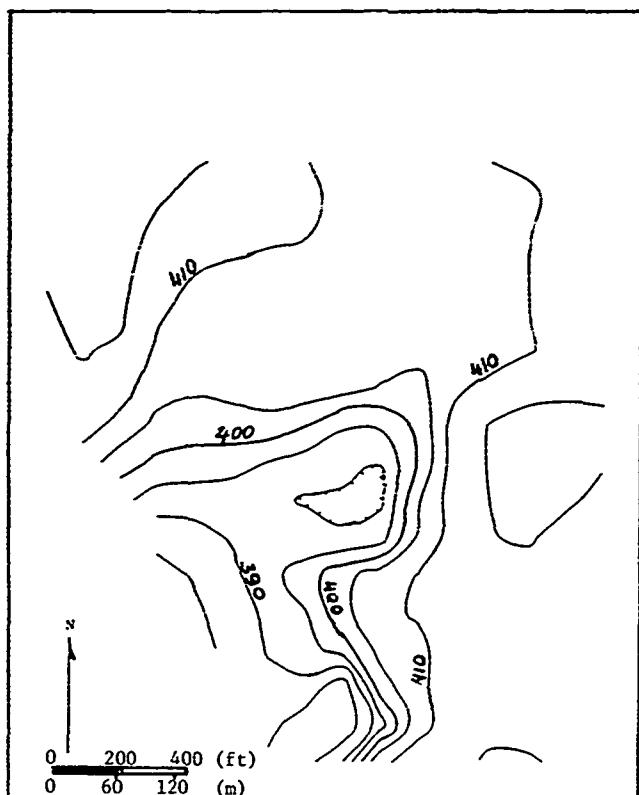
Figure 7. Bedrock Structural Elevation

1. A bedrock valley approximately 9 m (30 ft) deep is observed in the area (Figure 7). The thickness of the bedrock overburden in this valley is only 3-11 m thick (10-35 ft) while the thickness of the surficial overburden varies 24-34 m (80-110 ft). A cross-sectional map of the boreholes revealed the absence of the Bankston Fork Limestone in the bedrock valley. Thinly bedded immediate roof strata and the absence of the competent limestone bed in the roof together form favorable conditions for roof falls and localized rapidly occurring subsidence events such as A, B, C, and D.

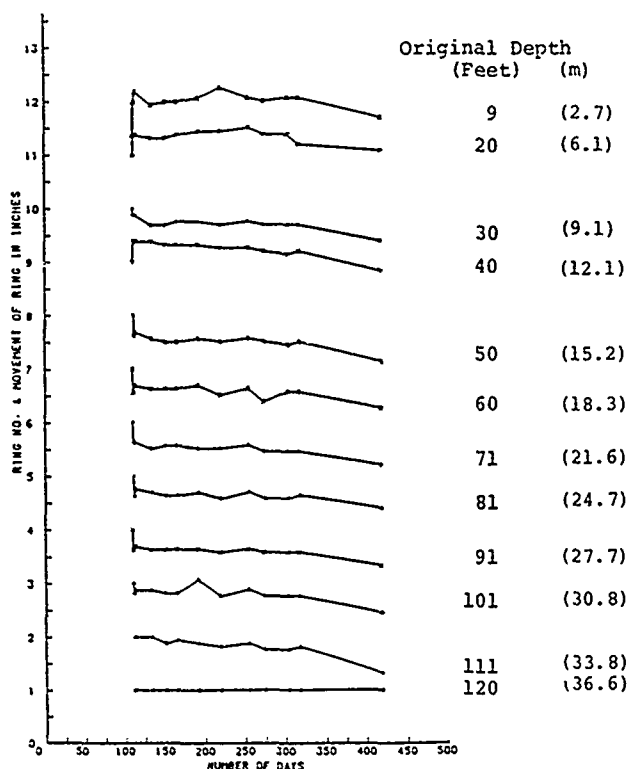
Figure 8. Subsurface Vertical Movements Sondex Hole IS2

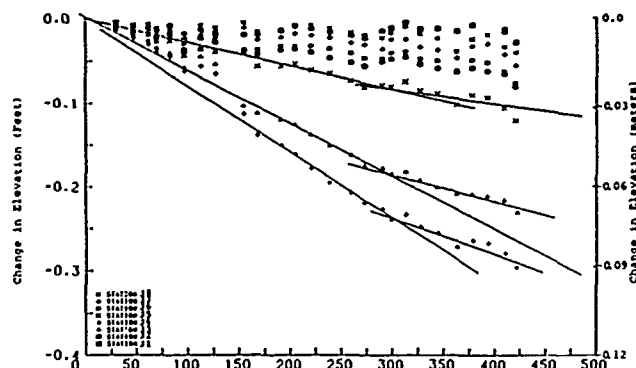
Figure 9. Subsidence Rate of Selected Stations on J Grid Line

The settlement is continuing even after a decade of mining although its rate seems to be decreasing (Figure 9). The expected vertical settlements due to this mechanism will depend upon claystone thickness, overburden pressure, percent extraction, and deformability of claystone. Over a long period of time, these movements may be large enough to cause differential coal pillar settlements and roof falls leading to surface subsidence. Consolidation and compression of claystone floor may be enhanced by the presence of water. In this mechanism, surficial overburden which is at or above its plastic limit (Figure 10) moves downward slowly as pillars settle. No extension strains are expected in the overburden since settlement rates are very small.

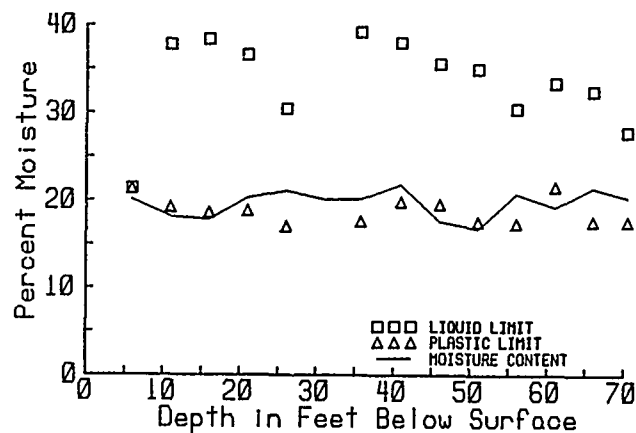
Figure 10. Comparison of Moisture Content, Liquid Limit, and Plastic Limit

- 6) Surficial overburden is above its plastic limit, it has an average moisture content of about 20% and it is relatively independent of the depth below the surface (Figure 10). Unconfined compressive strength of soil overburden varies from 75-925 kPa (11-134 psi) and it generally increases with depth below the surface. An elastic-perfectly plastic material behavior is indicated by stress-strain curves.

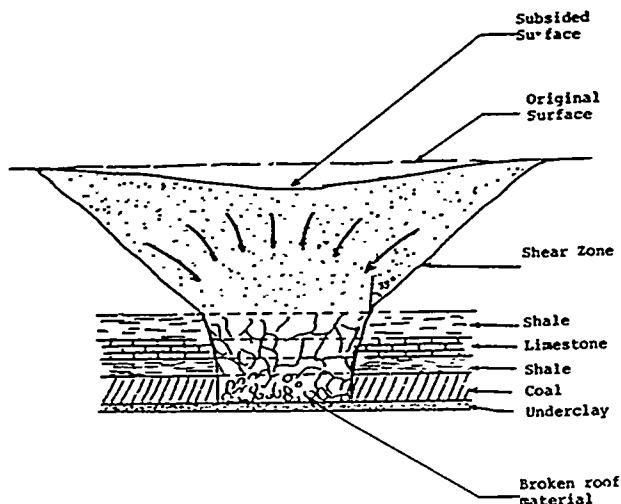
Figure 11. Schematic of Subsidence Mechanism 1

2. Fracturing of immediate roof strata due to wide intersections, discontinuities in the immediate roof, and/or prolonged excessive loading of thinly layered and weak overburden may cause the soil overburden to flow into mine voids causing surface subsidence (Figure 11). Differential settlements of pillars on weak claystone floor may also cause initiation or development of such subsidence movements. At least three or four such events (A, B, C, D) with vertical movements ranging from 25-90 mm (1.0-3.5 in.) were observed during the study period. At one such site where access was possible after the subsidence event occurred,

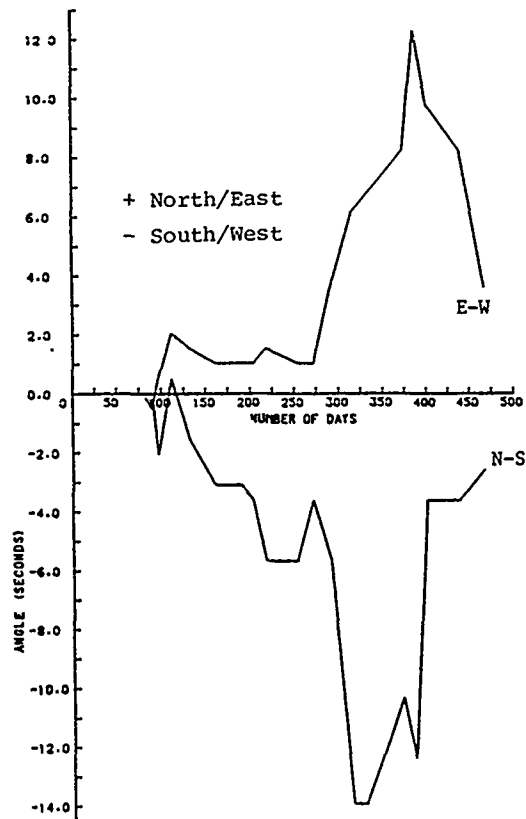
Figure 13. Angular Displacement of Tiltplate H20TP4.

$\pm 4$  seconds, the southern portion of the house is tilting most to the southeast, toward the center of the first depression, while the north side of the house is tilting toward the east but its magnitude is less than that of the southern portion of the house. A typical plot of the tilt is shown in Figure 13. A maximum horizontal displacement 2 mm (0.08 in.) is observed in the foundation since the tiltplates were installed. In house 10, 3 tiltplates were installed; one on the west side and two on the east side. The largest movement occurred on the west side of the house, with a tilt of 46 seconds to the west. This corresponds to a horizontal displacement of about 8 mm (0.32 in.).

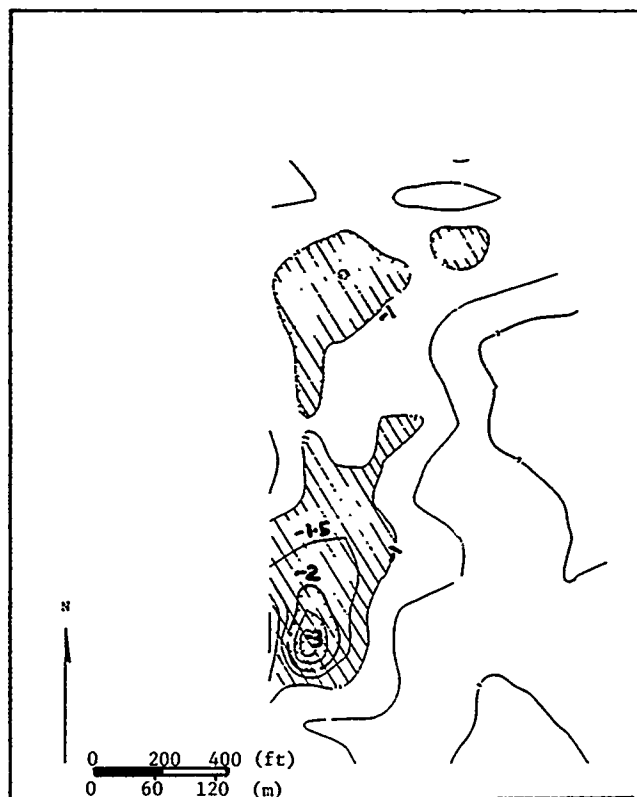
Figure 14. Localized Areas Currently Subsiding

7) Localized areas on the surface are continually undergoing subsidence (Figure 14). Most subsidence is observed adjacent to House 7 with a total vertical movement of about 89 mm (3.5 in.).

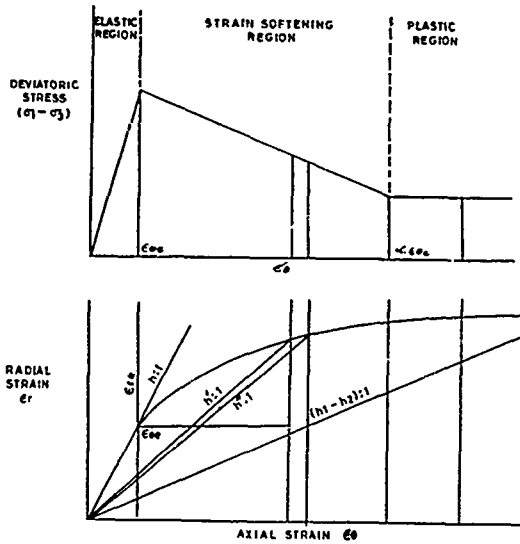
Fig.1 Assumed Material Behaviour Model

$\epsilon_{oe}$  is the major principal elastic strain at which the rock yields and goes from elastic to a plastic behaviour. The assumed relationship between the two strains is shown in the Fig.1.
